# PORCH HOUSE

Santa Pau, Girona  
2007-2010

The project consists of the rehabilitation of Can Creuet, a traditional 18th century farmhouse situated in Santa Pau, inside La Garrotxa Volcanic Zone National Park.

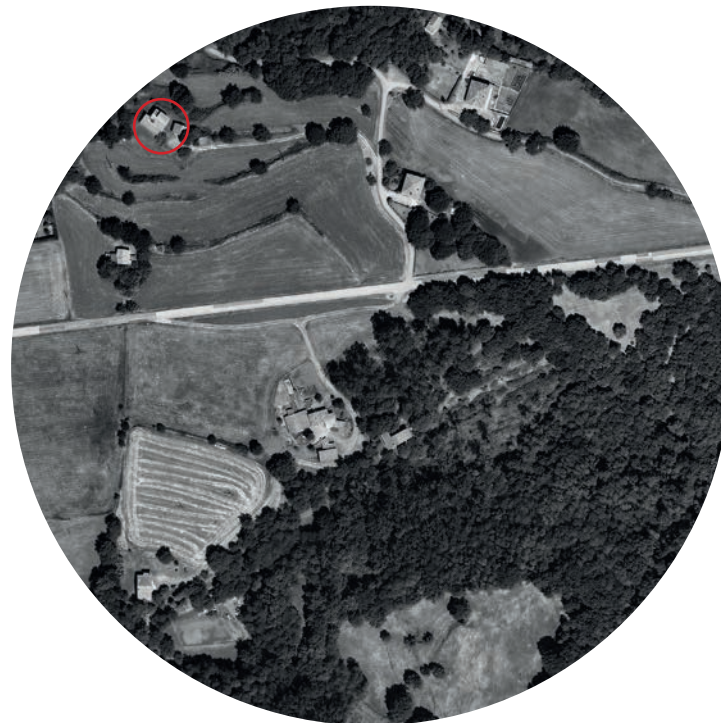
## F3

Porch House site plan. Institut Cartogràfic i Geològic de Catalunya (ICGC), 2016.

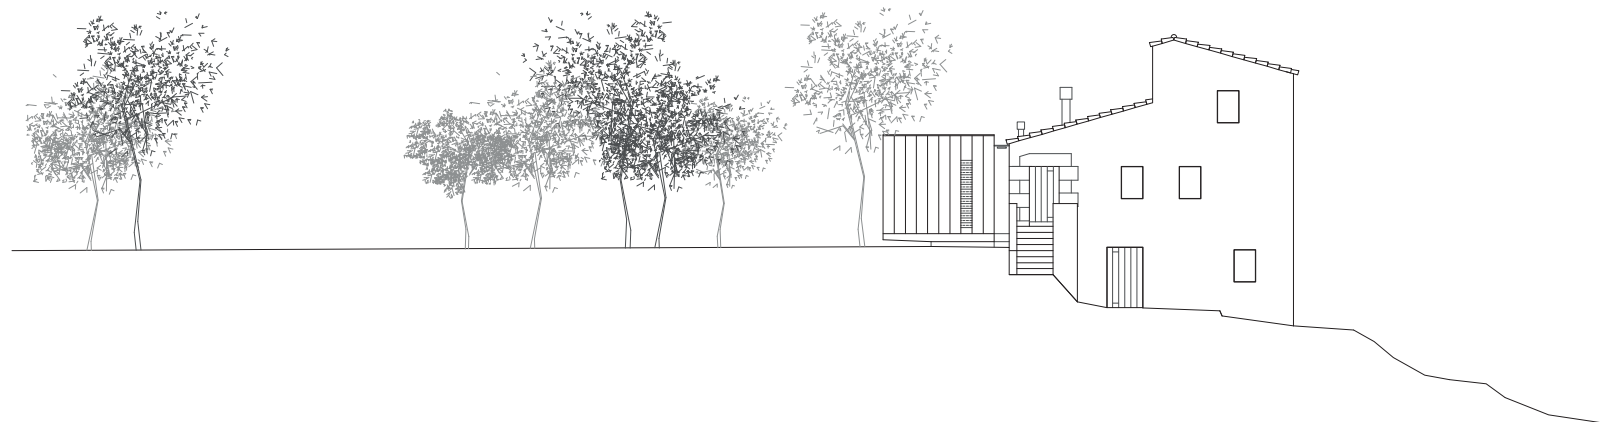
**F2**  
Eastern elevation.

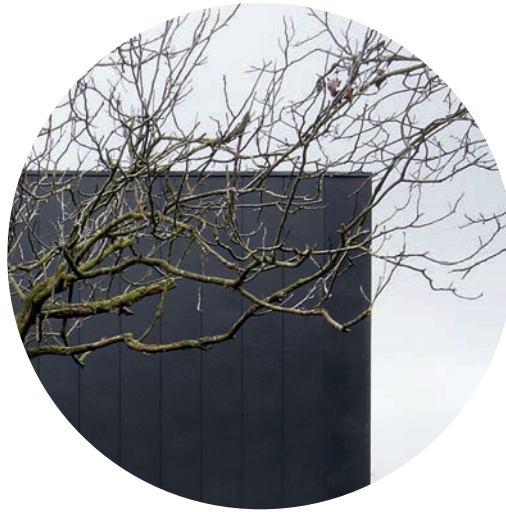
**F2**

Materiality: Zinc.

Its lightness and clear geometry contrast with the massiveness and irregularity of the original house. The black zinc skin of the new volume, prefabricated using industrial techniques, contributes to the neutrality of the intervention, focusing attention on the spectacle of the exuberance and variability of the surrounding landscape.

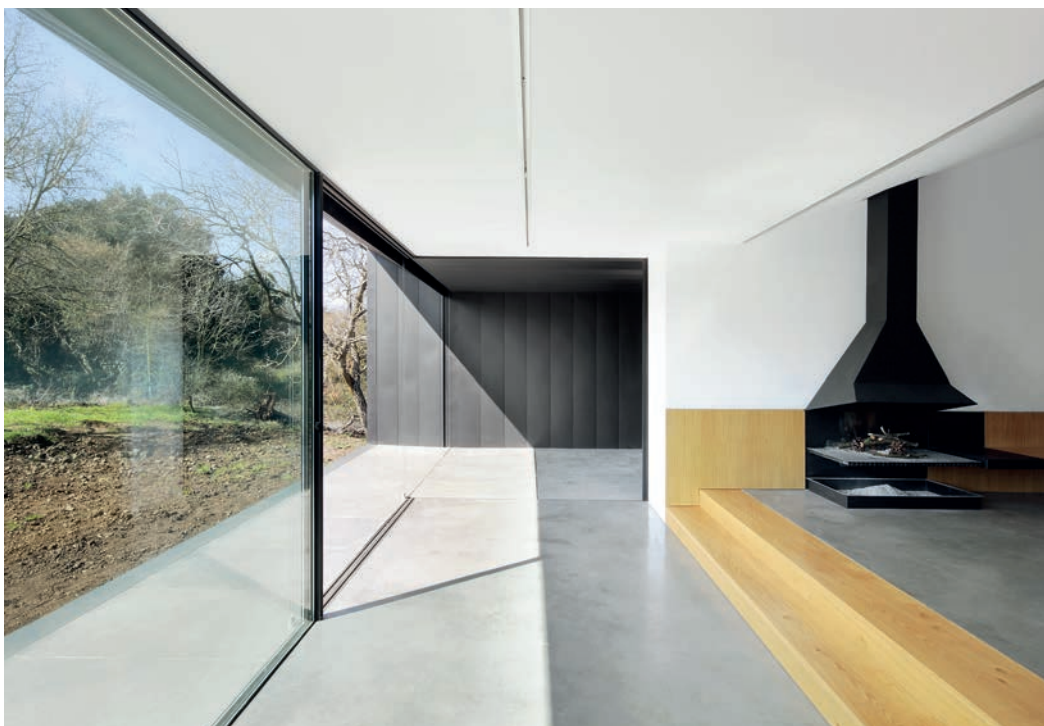
**F2**

Sliding windows promote complete continuity between the house and the porch.
